REGAL DOOR-INSWING-TRANSOM-2064-LITE  
OUTSIDE ELEVATION

**THERMALLY-BROKEN ALUMINUM FRAME + STEEL INSULATED SLAB**

Series: AD-5000

Name: (AD114) Inswing Door & Transom-2064-Lite

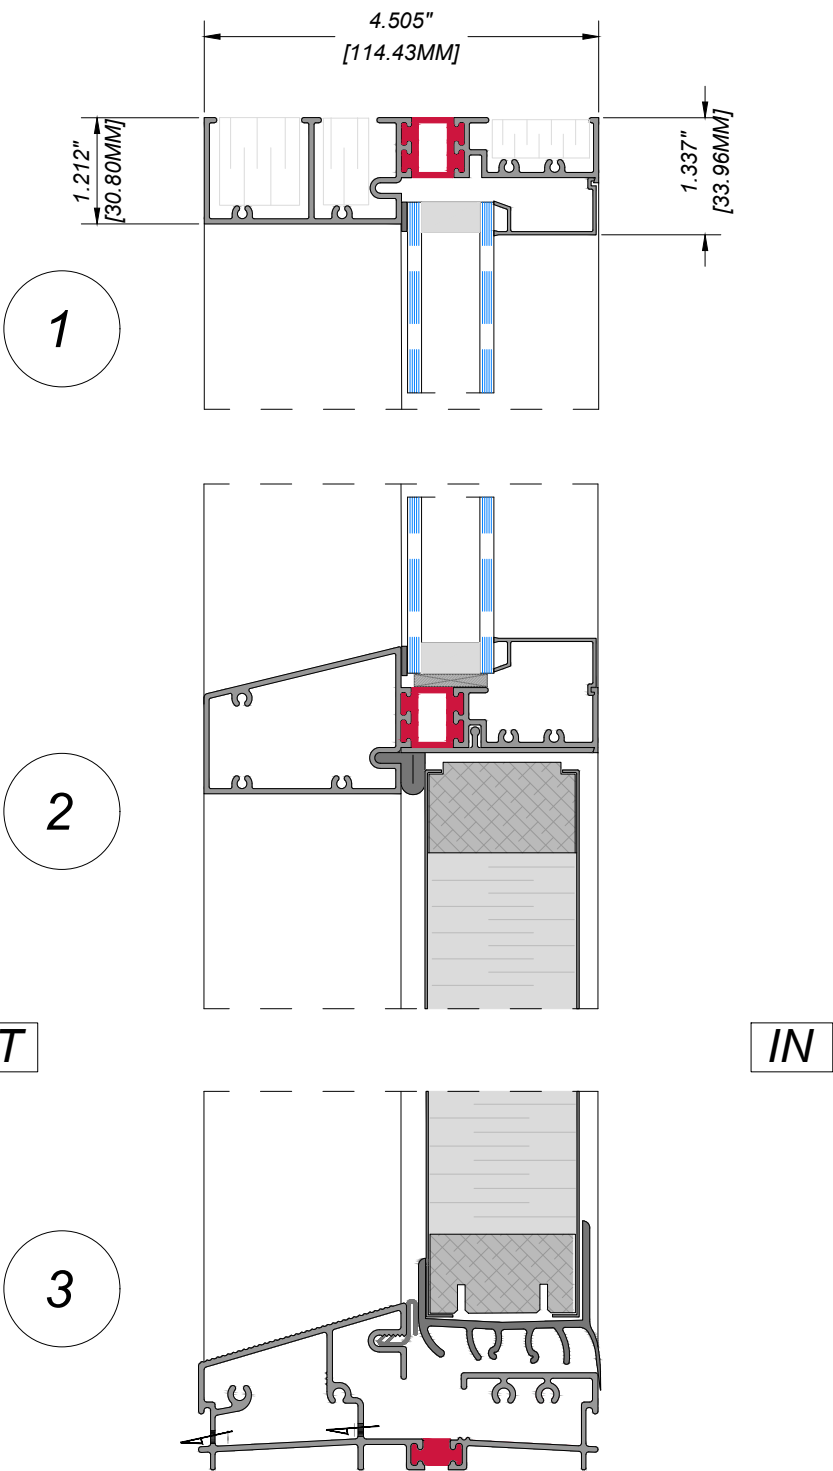
Drawing reference: AD114-02

REGAL DOOR-INSWING-TRANSOM-2064-LITE  
HEAD, TRANSOM & SILL DETAILS

VERTICAL  
SECTION

THERMALLY-BROKEN ALUMINUM FRAME + STEEL INSULATED SLAB

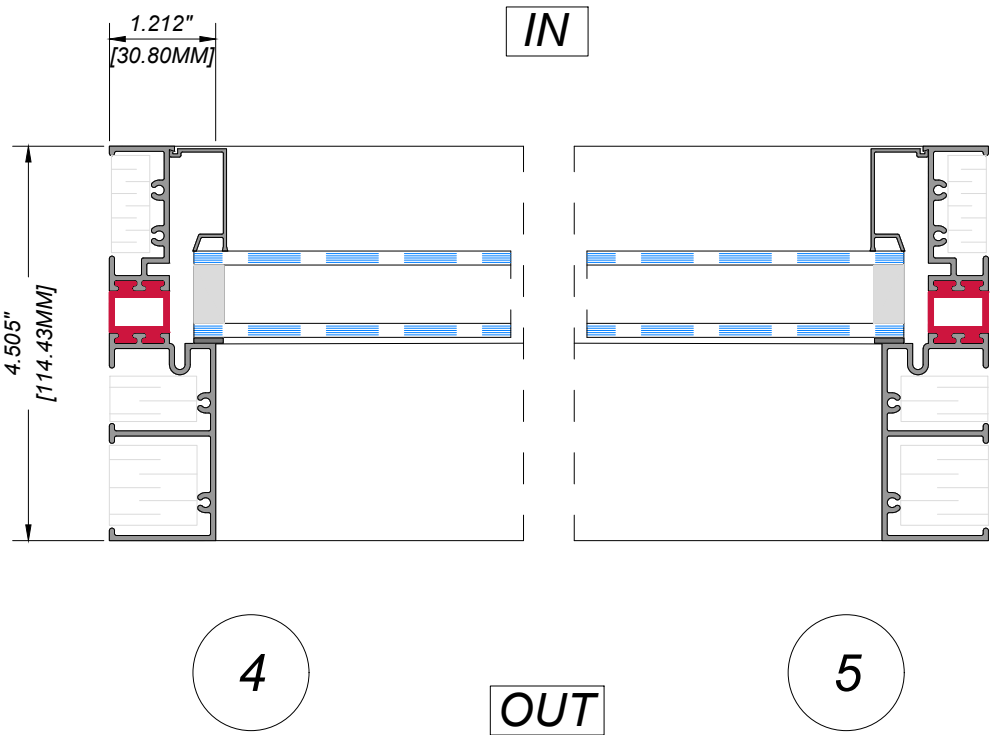
Drawing reference: AD114-03

REGAL DOOR-INSWING-TRANSOM-2064-LITE
TRANSOM SASH DETAILS

HORIZONTAL SECTION

THERMALLY-BROKEN ALUMINUM FRAME + STEEL INSULATED SLAB
